PM7326 S/UNI-APEX

ATM/PACKET TRAFFIC MANAGER AND SWITCH

ERRATA

ISSUE 1: APRIL 2000

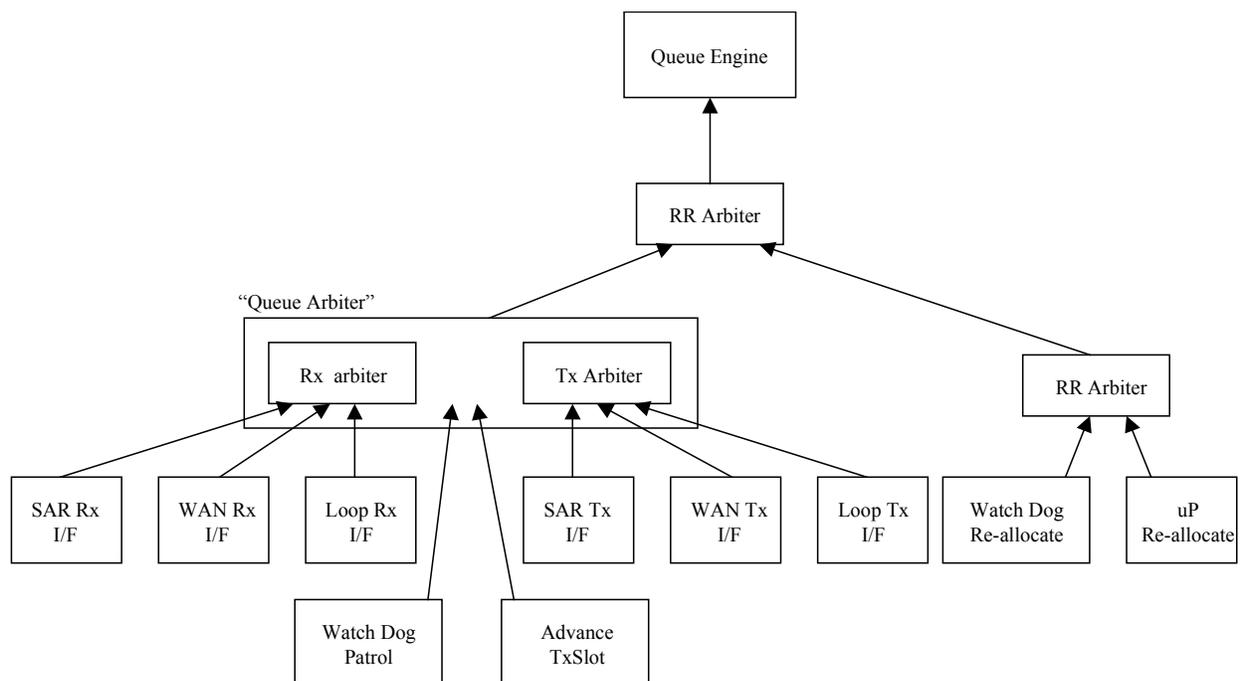
In very limited circumstances, the service arbitration process may be inconsistent with the description shown in Section 10.9.1 of the data sheet. Referring to Figure 14 in the data sheet (reproduced below), in some cases the watch dog reallocation procedure may temporarily cause the Rx or Tx arbiters to repeatedly

service the same interface (SAR, loop or WAN) until reallocation is complete. This could cause potential starvation of one of the remaining interface services.

This is caused because the Rx and Tx arbiters continue to cycle even when the watch dog arbiter has “won” the next Queue Engine opportunity. This effectively blocks the next interface selected by the Rx or Tx arbiter from being serviced for that cycle. If multiple ICIs simultaneously time out, the watch dog could cause the same interface to be repeatedly blocked, which could starve the interface.

The effect of this behavior is dependent on the activity at the interfaces. A possible worst case scenario would occur if all of the following conditions were present:

- Two out of three interfaces (WAN, Loop or SAR) have 2 or more cells in the internal FIFOs waiting to be serviced
- Frame contiguous queuing of VCs is being used
- The VC timeout watch dog is enabled (QWwdActive=1)
- The watch dog patrol is executed and discovers re-assembly time out errors in VCs that have sequential ICIs

The probability of a re-assembly time out for a sequence of VCs would be very low in normal operations. The most likely worst case scenario would be the simultaneous time out of all VCs associated with a given port due to a catastrophic fault on that port. If the VCs on any given port were mapped to non-sequential ICIs, the Rx and Tx interfaces would have an opportunity to successfully service requests between VC reallocations.

Typically there will be a device between the S/UNI Apex and the link layer that can perform an address resolution function (the S/UNI Atlas for example). This device could be also be used to map each VC on a port to non-contiguous ICIs.

One possible strategy would be to map VCs on even-numbered ports to even-numbered ICIs and VCs on odd-numbered ports to odd-numbered ICIs. This “striping” would ensure that the VCs associated with any port fault would not occupy contiguous ICIs and would therefore avoid the service arbitration behavior described above.
