Active T89C51CC01 Errata List

T89C51CC01UA
T89C51CC01CA

Errata Sheet

Rev. 4131C-8051-11/02

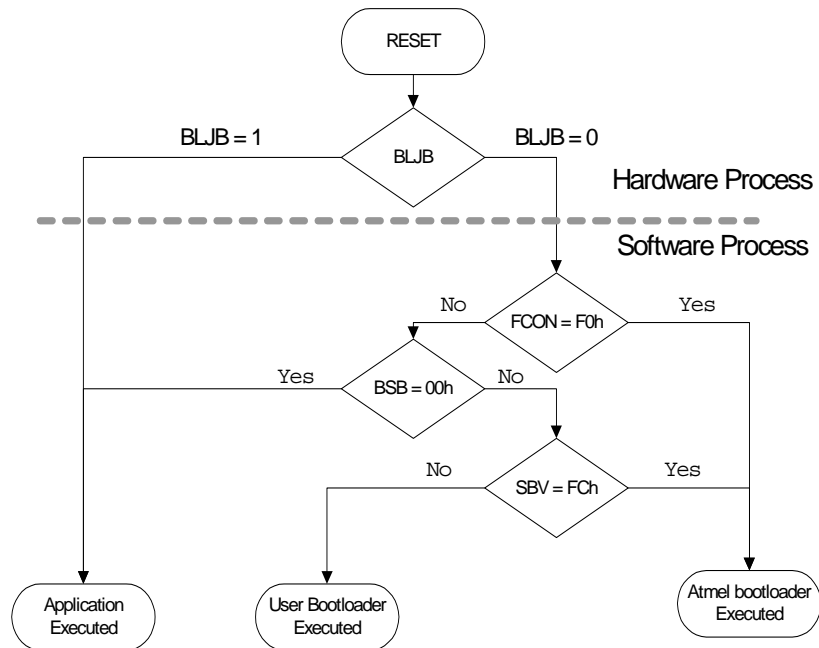
Version 1.2:

4. Boot Process Compatibility

There are some differences between Boot process of bootloader 1.2 and newer versions.

Workaround

Use the fuse bit BLJB to start the application on both versions.
