**DDX Multichannel
Digital Audio Processor****ERRATA**

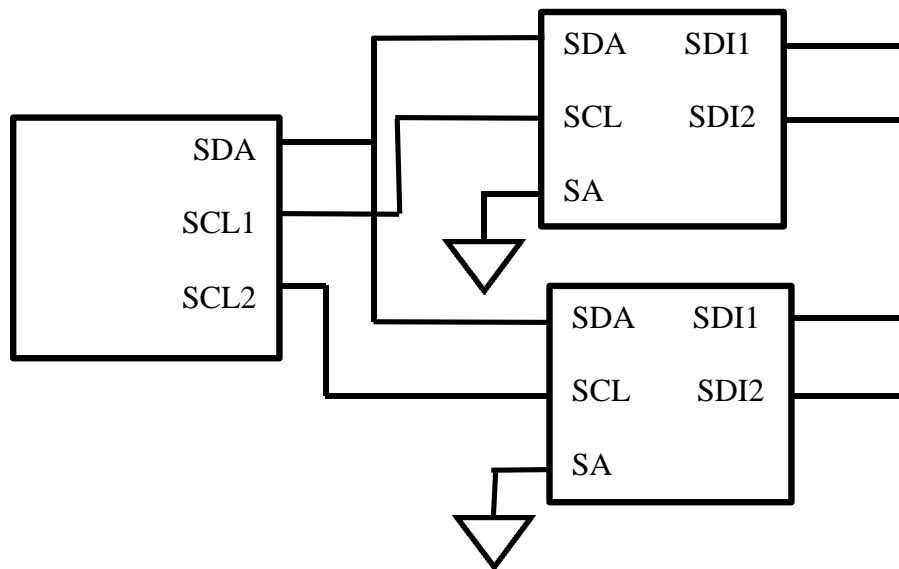
First Choice: Ground SA on both controllers

D] When using the DDX-4100 in dual processor configuration, **there is an operational error when using the combination of I²C address = 0011 111x (SA {pin 11} connected to Vdd) and serial I²S input SDI1 (pin 1).** The serial data input SDI1 will not operate per the datasheet in this configuration. Using I²C address = 0011 110x (SA {pin 11} connected to ground) the device operates properly as described in the datasheet. Single processor configurations are not affected by this error, provided the SA pin is connected to ground. There are two choices for a corrective action.

The first choice is to ground SA pin 11 on both ICs, causing both ICs to have the same I²C address = 0011 110x, and use two separate I²C clock pins (SCL pin 10) from the system microcontroller, one for each IC, to address the two processors independently. When communicating with the first processor, the SCL signal connected to the second must remain static and vice versa. The advantage is that full functionality is achieved and no other changes are required. The disadvantage is that there is an additional signal required from the system microcontroller.
