# ES\_LPC435x/3x/2x/1x Errata sheet LPC435x/3x/2x/1x Rev. 2 — 20 October 2012

**Errata sheet**

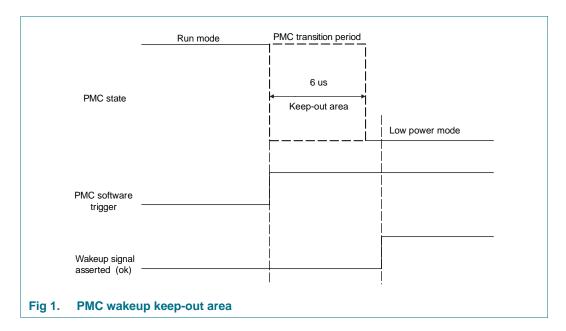
When the chip is in a transition from active to Deep Sleep, Power Down, or Deep Power Down, wakeup events are not captured and they will block further wakeup events from propagating. The time window for this transition is 6 uS and is not affected by the chip clock speed. After a wakeup event is received during the PMC transition, the chip can only recover by using an external hardware reset or by cycling power.

Make sure that a wakeup signal is not received during the Deep Sleep, Power Down, or Deep Power Down transition period. An example circuit to work around this could include an external 6 uS one shot which could be triggered via software using a GPIO line when entering Deep Sleep, Power Down, or Deep Power Down mode. The one-shot's output could be used to gate the wakeup signal(s) to prevent receiving a wakeup signal during the PMC transition period. Depending on the system design, it may also be needed to latch the wakeup signal(s) so that they will still be present after the one-shot's 6 uS timeout.
