## KSZ8041 Silicon Errata and Data Sheet Clarification

This document describes known silicon errata for the KSZ8041 family of devices, which includes the following:

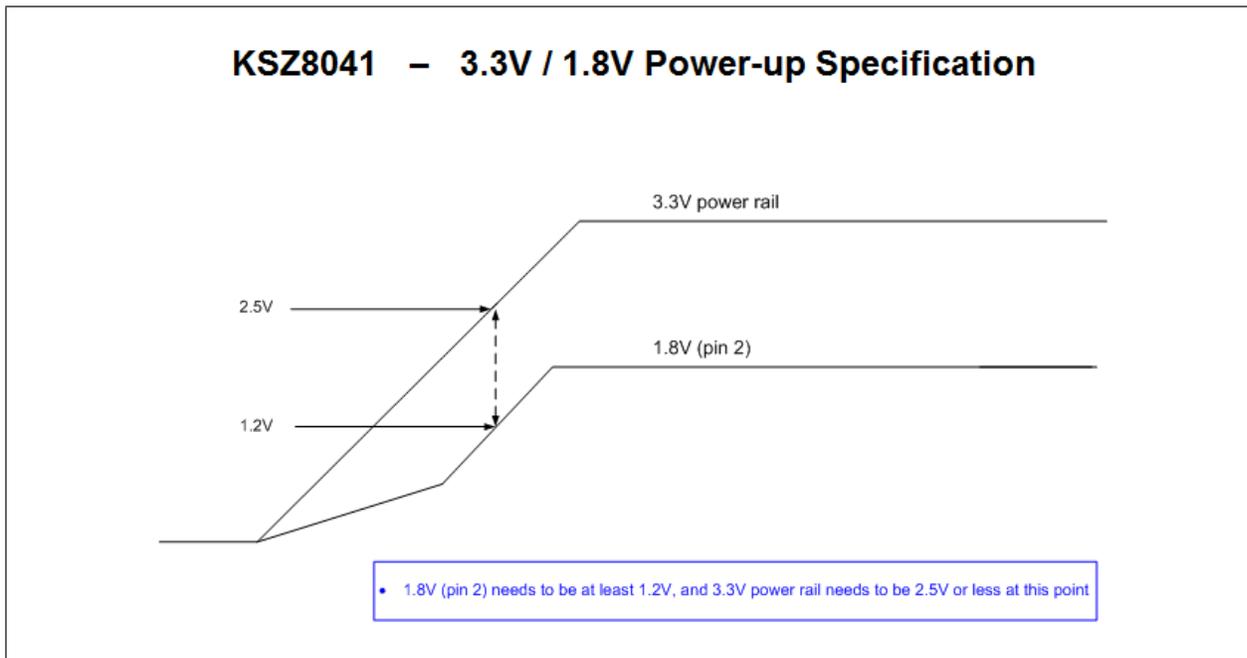
A small percentage (<1%) of devices can potentially encounter pin strapping failures with fast 3.3V supply rise times (<150us) or slow core rail rise times, due to a large bulk storage capacitor value (10uF or greater) for the 1.8V core.

When this errata occurs, pin strap values may not be correctly latched.

Reduce the 1.8V core bulk storage capacitor from 10uF to 1.0uF and ensure the 3.3V supply rise time is 250us or greater.
