CY7C129*DV18/CY7C130*DV25
 CY7C130*BV18/CY7C130*BV25/CY7C132*BV25
 CY7C131*BV18 / CY7C132*BV18/CY7C139*BV18
 CY7C191*BV18/CY7C141*AV18 / CY7C142*AV18/
 CY7C151*V18 /CY7C152*V18

Errata Revision: *C

May 02, 2007

RAM9 QDR-I/DDR-I/QDR-II/DDR- II Errata

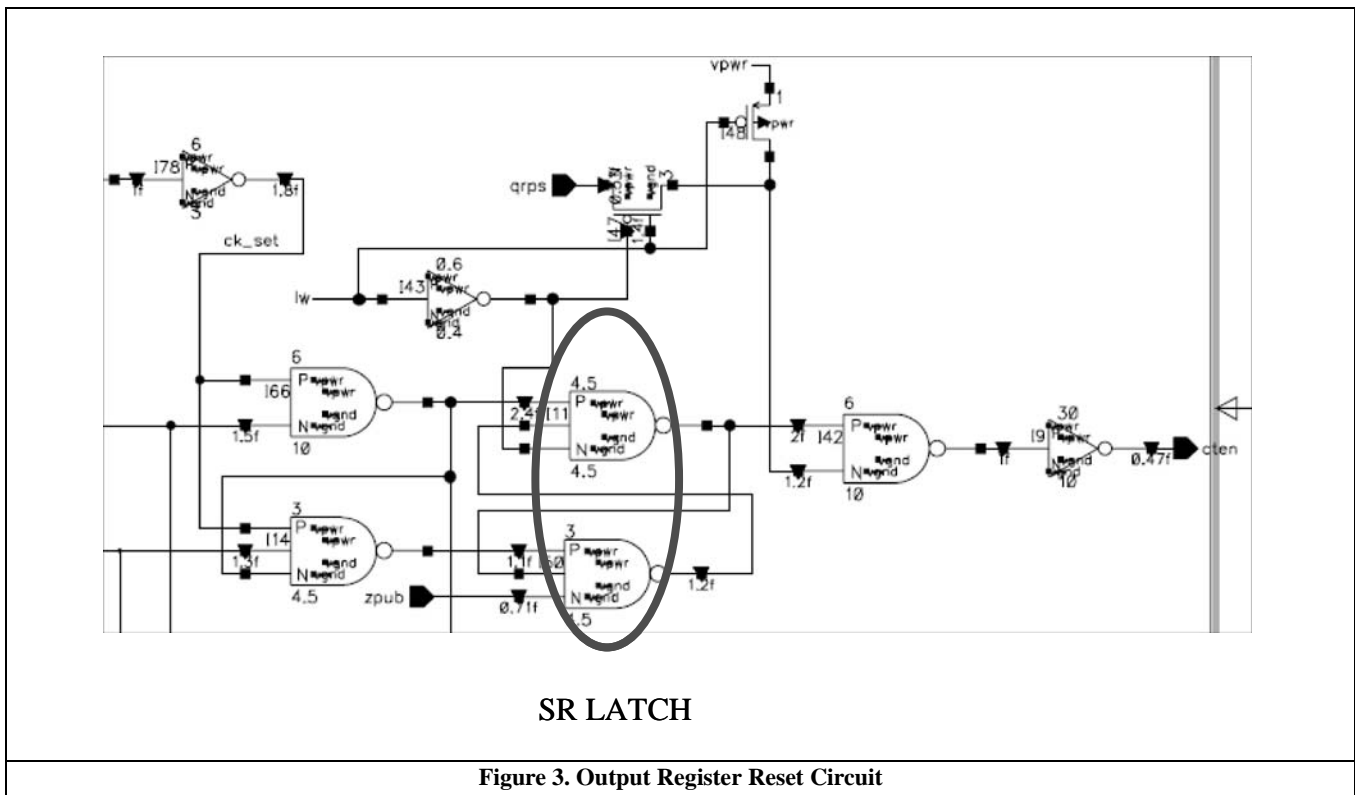
This issue involves the output buffer entering an unidentified state when the input signals (only Control signals or Clocks) are floating during reset or initialization of the memory controller after power up.

Figure 3 shows the output register Reset circuit with an SR Latch circled. This latch has two inputs with one of them coming from some logic affected by the clock and RPS#(QDR) or WE# and LD#(DDR). The issue happens when clocks are glitching/toggling with controls floating. This will cause the SR latch to be taken into an unidentified state. The SR Latch will need to be reset by a dummy read operation if this happens.

This is viable only if the customer has the trigger conditions met during reset or initialization of the memory controller after power up. In order for the workaround to perform properly, Cypress recommends the insertion of a minimum of 16 “dummy” READ operations to every SRAM device on the board prior to writing any meaningful data into the SRAM. After this one “dummy” READ operation, the device will perform properly. “Dummy” READ is defined as a read operation to the device that is not meant to retrieve required data. The “dummy” READ can be to any address location in the SRAM. Refer to Figure 4 for the dummy read implementation.
