## Application Note of IT8761F for Power On Strapping Circuit

July 1, 1999

### ➤ Power on strapping circuit needs extra attention when a “0” setting is selected

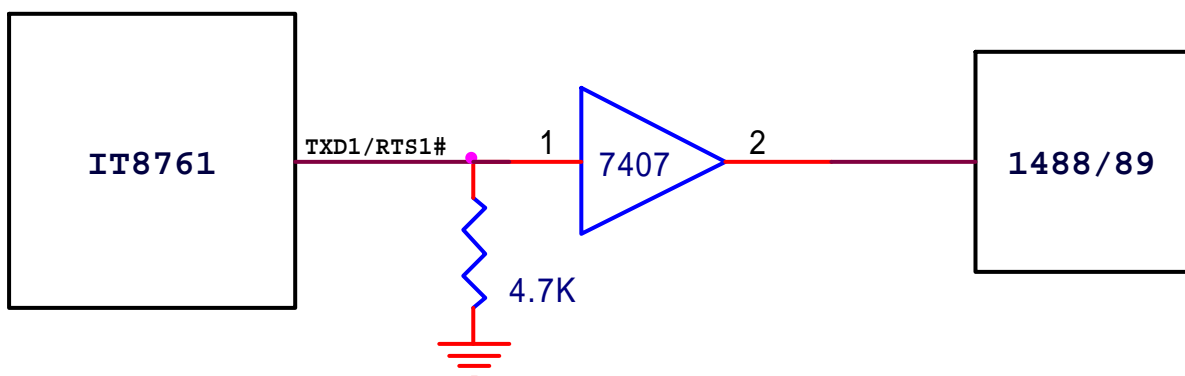
Description: Due to IT8761 Rev. B power on strapping pins selection, a “0” setting may not be strapped in correctly.

Cause: IT8761 chooses TXD1 and RTS1# pins for power on strapping setting, since these two pin also connect to 1488/1489 type line driver and some of the line driver internally have +12V pull up with a 11K ohm resistor, this will cause the “0” setting not correctly strapped.

Suggestion: (1) Choose a small enough value pull down resistor to make the strapping line voltage below 0.5V when system is reset. A suggested resistor value is 680 ohm.  
(2) Implement a redundant gate between IT8671 and line driver to isolate the interfere of the internal pull up of 1488/89 line driver as following circuit.
