## KSZ8041 Silicon Errata and Data Sheet Clarification

This document describes known silicon errata for the KSZ8041 family of devices, which includes the following:

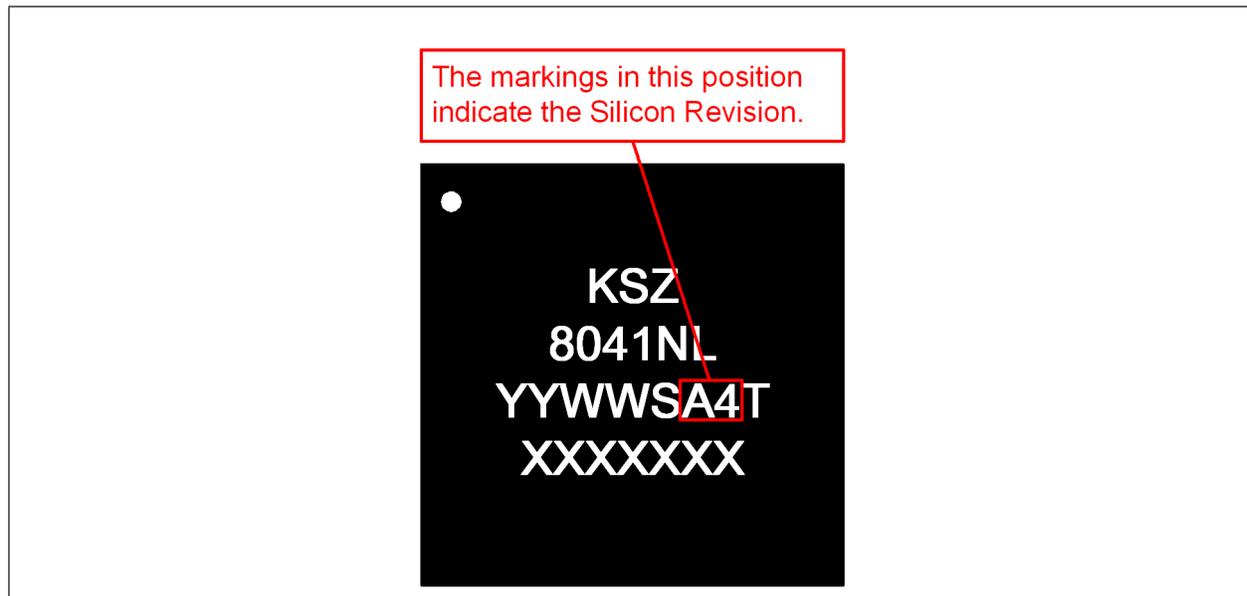
**FIGURE 1: TOP MARKING SILICON REVISION INDICATION**

The silicon errata discussed in this document are for silicon with silicon revisions as listed in [Table 1](#). The silicon revision can be determined by the device's top marking as indicated in [Figure 1](#). A summary of KSZ8041 silicon errata is provided in [Table 2](#).

**Note:** The purpose of [Figure 1](#) is to detail the top markings of an example part and highlight the location of the silicon revision. Other top marking values may differ (lot codes, location of manufacture, etc.).
