PM5342

SPECTRA-155

**SONET/SDH PAYLOAD
EXTRACTOR/ALIGNER**

REVISION E DEVICE ERRATA

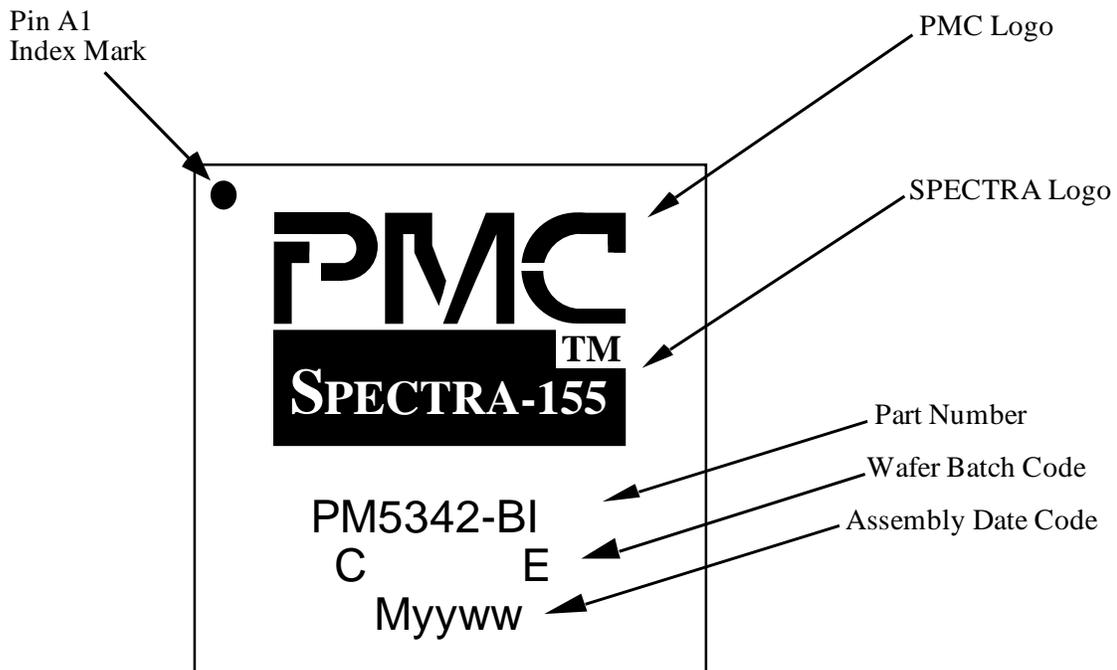
Figure 1: PM5342 SPECTRA-155 Branding Format

TOP VIEW
SCALE : 2:1
(APPROX.)

The information in this document applies to the PM5342 SPECTRA-155 revision E device only. The device revision code is marked at the end of the Wafer Batch Code on the face of the device (as shown in Figure 1). PM5342 SPECTRA-155 Revision E is packaged in a 256 pin Super BGA package.
