**PM73123**

**AAL1GATOR-8**

**REVISION A DEVICE ERRATA**

**ISSUE 1: FEBRUARY 2001**

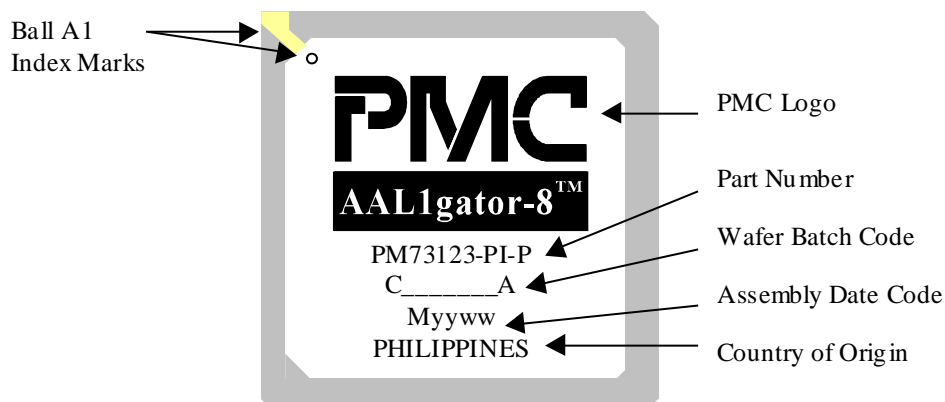
The device revision code is marked at the end of the Wafer Batch Code on the face of the device (as shown in Figure 1). The PM73123-PI is packaged in a custom 324 PBGA, with a 23 x 23 mm body size, and a ball pitch of 1.00 mm.

**Figure 1. PM73123 AAL1gator-8 Branding Format.**
